Microstructure Effects on Creep Behavior of Next Generation of Refractory Alloys for Very High Temperature Applications

Vijay K. Vasudevan and Keith J. Leonard

Final Report

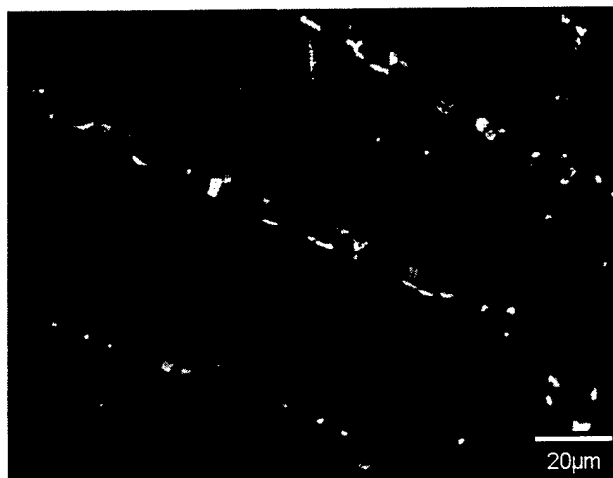
Figure 4. BSE micrographs showing microstructure of (a) As-cast Mo-12.5Si-25B alloy, (b) as-cast+ homogenized (1700°C, 24h) Mo-12.5Si-25B alloys and (c) as-cast + homogenized Mo-12Si-12B alloy.

The cast microstructure of the Mo1225 material, Figure 4(a), contained long plates of the T2 phase formed through the decomposition of a higher temperature phase that had solidified from the melt. This microstructure correlates with the possible MoB primary solidification field from which the composition of the T2 based alloy falls into, as determined by Nunes *et al.* [7]. In the cast microstructure, the regions between the T2 plates contained a mixture of α -Mo solid solution, Mo_3Si and T2, as verified by XRD (Figure 5(a)). Following homogenization of this alloy at 1700°C, 24 h, the T2 laths could still be distinguished, though the α and Mo_3Si volume fractions were significantly reduced along with an increase in width of the T2 laths (Figure 4(b)).

The microstructure of the homogenized Mo1212 material (Figure 4(c)) contained a random distribution T2 and Mo₃Si particles in a matrix of α (Figure 5(b)). The α grains were discontinuous throughout the samples, although a bimodal size distribution was observed. This distribution is believed to be the result of a significant increase in the volume fraction of α at 1700°C [current work], rather than from the removal of the segregation from solidification.
